## Nihoku Ecosystem Restoration Project Fact Sheet

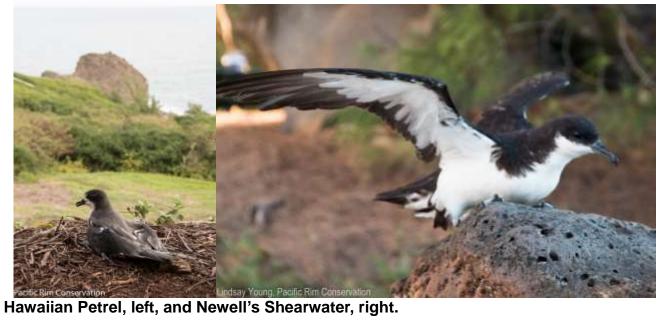
Nihoku fenceline

**Project site facing East**

• Enclosed space: 2.4 hectares (6.7 acres)
	Cost: \$300,000 (for both materials and labor); used local labor to build
Fence Features	Marine grade stainless steel for strength and corrosion resistance
	Small chain-link mesh to prevent even 2-day old mice from entering
	Rolled hood to prevent animals from climbing over
	Mesh extends into horizontal skirt at base to prevent access by digging animals
	Gates for access for guided tours and refuge staff and vehicles
